DEFORMATION AND FAILURE IN EXPLOSIVELY LOADED STEEL STRUCTURES

T.G. Turner*, N.M. Burman*, D.V. Ritzel* and R.H. Grzebieta**

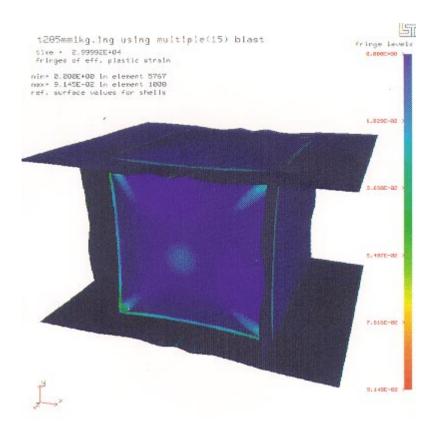
A typical result of test rig deformation for an LSDYNA3D FEA simulation of a 1000g charge test is shown in Figure 3 for comparison with the experimental results of Figure 2. The FEA test rig simulation is seen to closely follow the general features of the experimental test rig deformation, including the development of the unsupported edge buckling. Comparisons of measured experimental and predicted test panel deformation showed excellent correspondence. These FEA simulations also highlight the development of high effective plastic strain levels in the panel edge hinge regions as well as extremely high concentrated strain levels adjacent to the 3D corner positions, Figure 3. With increasing explosive charge size the deformation, ie degree of curvature, in the simulated panel hinge and 3D corner regions increased dramatically mimicking the level of measured experimental curvature in these positions.

Figure 3. LSDYNA3D simulation of test rig with 5mm test panels for 1kg Pentolite Charge.

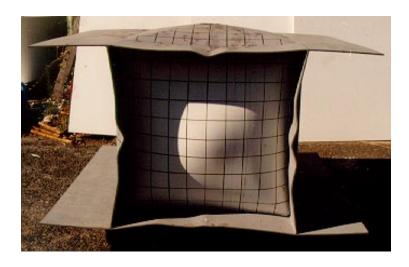
Failure did not occur in the test with the 4mm test panels, Figure 4, although the overall deformation increased over that shown by the 5mm sample panel tests with the equivalent explosive charge. In the 3mm firing one test panel failed completely along the panel boundary, while the opposite test panel showed partial (incipient) boundary failure in this same region, Figure 5. Testing of the 2.5mm sample panels in the standard test rig produced complete failure for both test panels along the panel boundary, Figure 6. The failure mode observed for these tests was identical to that found in earlier test series [1-5].

Figure 4. Deformation of 4mm sample panel for 1000g Pentolite charge.

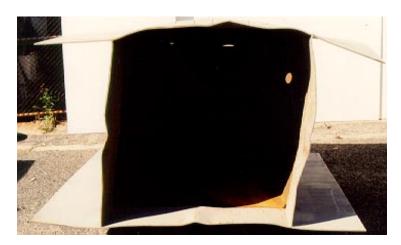
Figure 5. Deformation and failure of 3mm sample panel for 1000g Pentolite Charge.

The results of these experimental and FEA simulations as well as previous experiments show that for this type of loading regime, failure occurs at the panel boundaries when the stress/strain levels in the boundary hinge area exceed a yet undetermined critical level. Examination of the failed panel boundary edges showed tensile shear failure surfaces with identical characteristics to those observed in earlier cubicle tests. The proximity of the observed failure position and the FEA predicted high bending strains, previously associated with edge hinge formation, indicates that edge failure may result from a combination of high membrane tensile loading and the severe hinge bending stresses/strains when the panel is below a critical thickness or is weakened by the edge joining procedure or one of its artefacts.

Once failure is initiated in one or more of these high stress/strain hinge or weakened areas, the kinetic energy of the test panels generally continues the failure process through tearing along the panel boundary in the region of the perimeter weld. Although panel boundary failure initially occurs in and adjacent to the hinge/weld attachment region, and may have been initiated by the associated weaknesses introduced by that joining technique, the tearing failure path is not restricted to the weld or the adjacent weld affected zone, but instead follows path of least resistance along the hinge line and which often passes through the parent plate material.

From these FEA predicted and experimental results it can be postulated that panel boundary failure will occur for a given load level when the panel is either below the critical thickness (cross sectional area) or the panel boundary joining technique introduces a weakened region at or adjacent to the panel edge hinge. Accordingly, to resist failure at a given load level, panels must be both of adequate thickness and the edge hinge area must be strengthened by improving panel edge joining quality or by shifting the panel edge join away from the area of intense bending, ie joint attachment redesign. A series of tests has been planned to study the

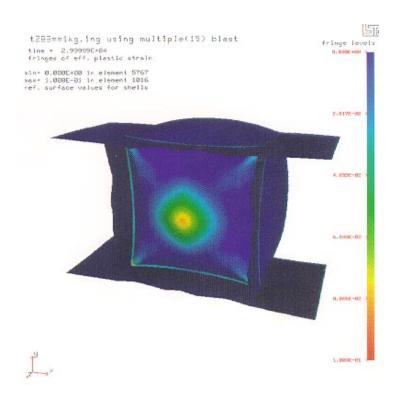
Figure 7 shows the FEA simulation of the 3mm panel test rig for a 1000g explosive charge. This FEA simulation and experimental measurements showed similar features to the simulation identified in Figure 3 but with increased overall deformation as well as hinge and 3D corner strain levels.

Figure 7. LSDYNA3D simulation of test rig with 3mm test panels for 1 kg Pentolite Charge.
